**AFRL-RH-WP-TR-2016-0095**

# **DYNAMIC PERFORMANCE ASSESSMENT OF SIDE FACING TROOP SEATS DURING IMPACT**

**April 2016  
Final Report**

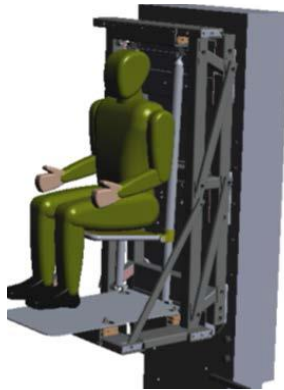
**Figure 3. Pure Vertical**

The pure vertical test configuration had no offset relative to the positive z-axis. This orientation is shown in Figure 3 below.

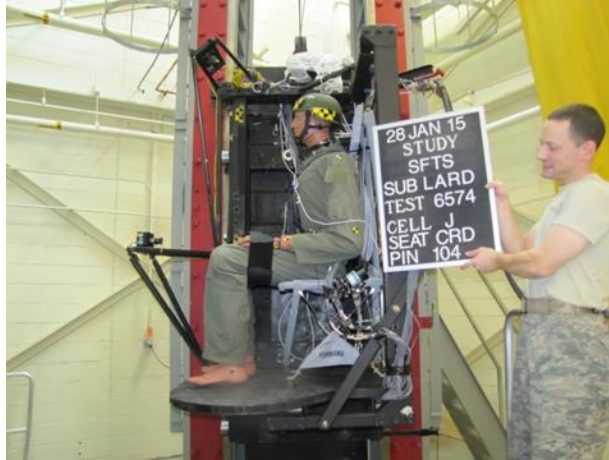
**Figure 4. Combined Vertical**

The combined vertical test configuration consisted of a 30 degree pitch and 10 degree roll relative to the acceleration pulse. This orientation is shown in Figure 4 below.

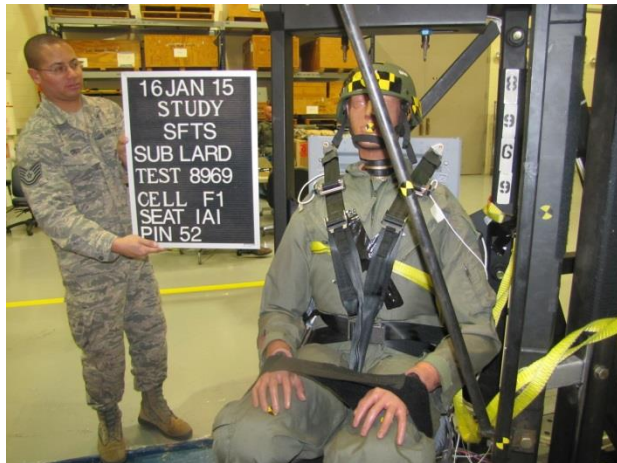
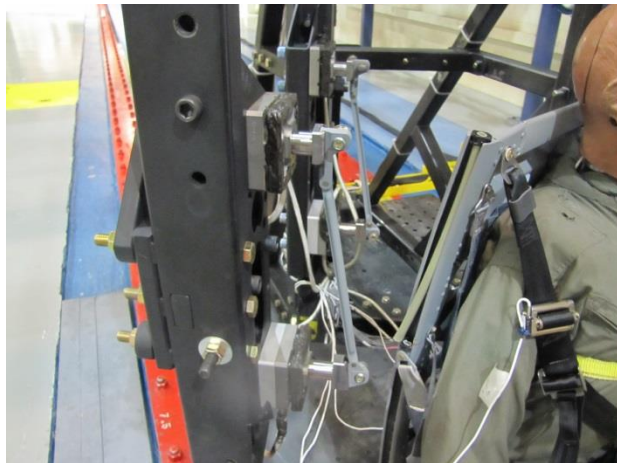
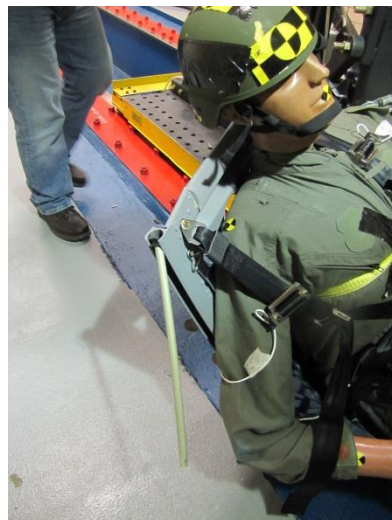
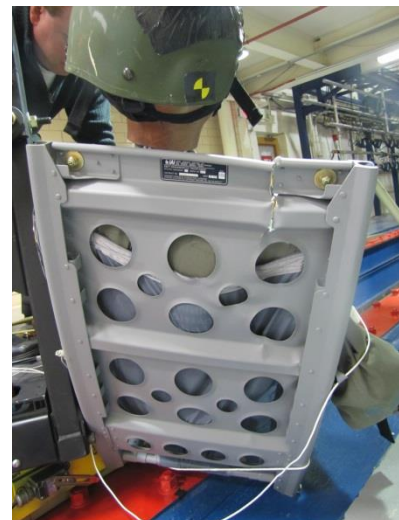
HIA8969- Cell F1, CH, CV-22, LARD, 24.36 G, 53.02 ft/s, 62.3 ms rise time

HIA8969 was the first CH impact test at the higher energy level. The manikin remained in the seat fixture; however, the seat fixture failed at both mounts and became detached from the sled and test structure. Torso belt force exceeded accepted limit, reaching 5257 lbs during impact. All electronic data channels were present and continuous allowing data to be successfully collected. Neck moment index X (UNMIx) also exceeded the accepted limit, reaching 1.0243 during impact. After impact the restraint buckle released with 16 lbs of force.

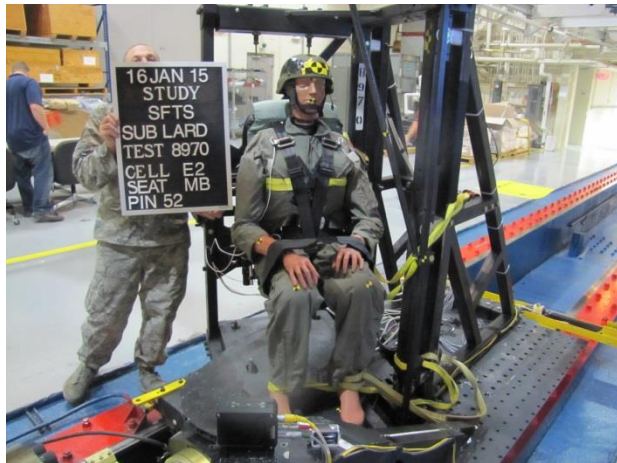
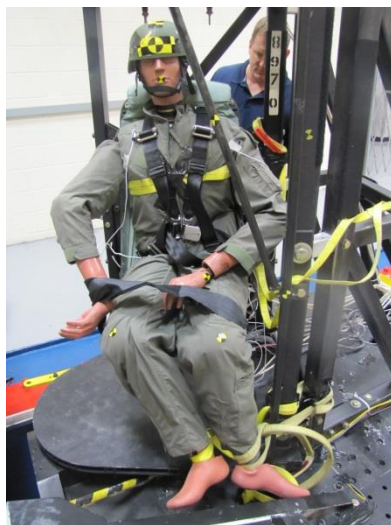
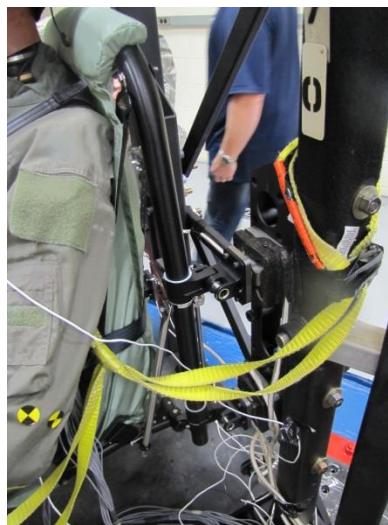
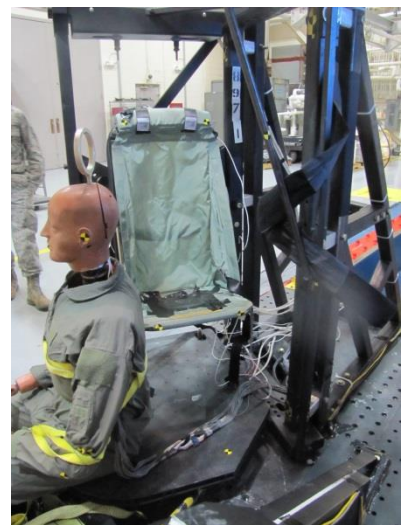
**HIA8970- Cell E2, CH, CH-53, LARD, 17.06 G, 46.14 ft/s, 73.8 ms rise time**

HIA8970 was the first CH test with the CH-53 seat. No structural damage occurred during this test. Torso belt force exceeded accepted limit, reaching 4989 lbs during impact. All electronic data channels were present and continuous allowing data to be successfully collected. Neck moment index X (UNMIx) also exceeded the accepted limit, reaching 1.2657 during impact. After impact the restraint buckle released with 21 lbs of force.

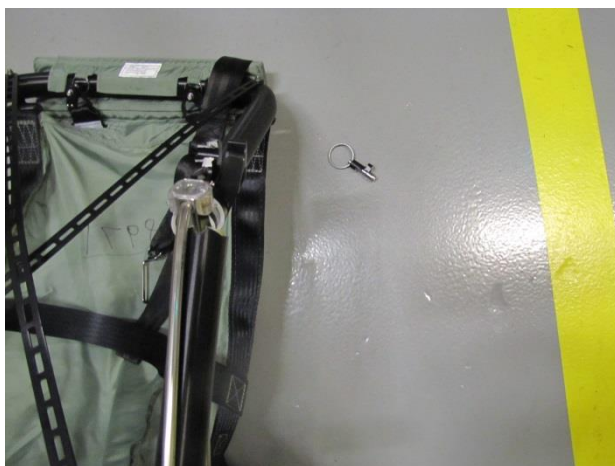
**HIA8971- Cell F2, CH, CH-53, LARD, 23.7 G, 52.63 ft/s, 57.7 ms rise time**

HIA8971 was the second CH test with the CH-53 seat, but at a higher energy level. The seat fixture did show extensive damage, including complete fracture of both stroking rods causing the manikin to become partially dislodged from the seat in a hunched position. Torso belt force exceeded accepted limit, reaching 5644 lbs during impact. Neck moment index X also exceeded the accepted limit, reaching 0.9310 during impact. After impact the restraint buckle released with 35 lbs of force.

The CH-53 seat had no visible structural damage at the low G level test and performed the best of the three seats. The seat fixture did show extensive damage at the High G test. There was complete fracture of both stroking rods causing the manikin to become partially dislodged from the seat in a hunched position.

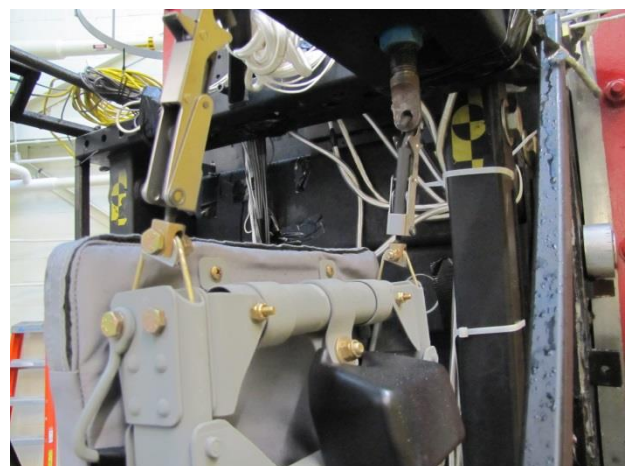
**VDT6571- Cell G, PV, Legacy H-60, LOIS, 14.95 G, 31.2 ft/s, 55.4 ms rise time**

VDT6571 was the first PV impact test performed, and also the first test using the LOIS manikin. The seat did slightly stroke at both top mount points. No structural damage was recorded for this test. All electronic data channels were present and continuous allowing data to be successfully collected. After impact the restraint buckle released with 26 lbs of force.

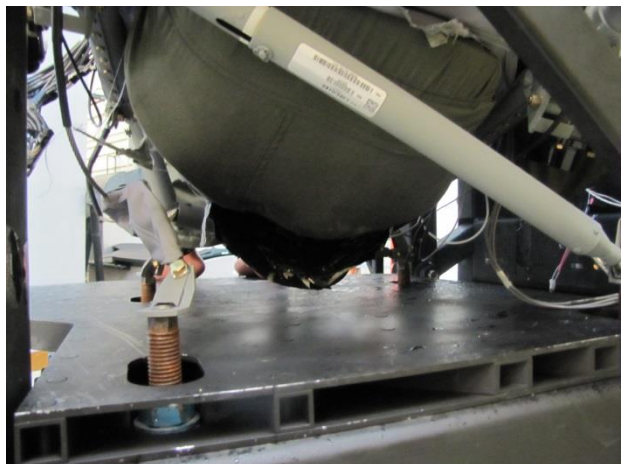
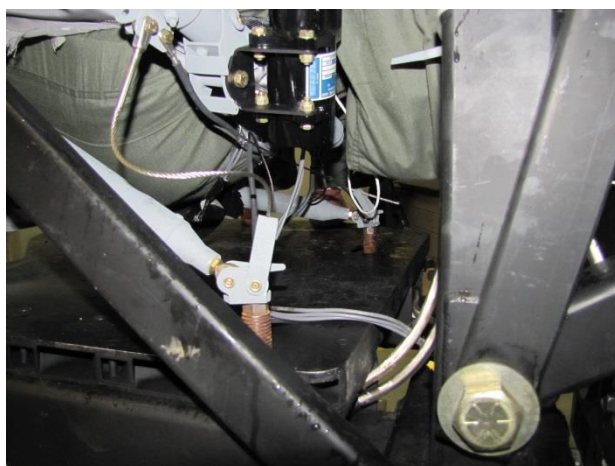
**VDT6574- Cell J, PV, Legacy H-60, LARD, 35.43 G, 48.94 ft/s, 33.2 ms rise time**

VDT6574 was the second PV test with the Legacy H-60 and the LARD manikin, but at a higher energy level. The seat fixture did show extensive damage, including fracture of the front seat leg and a significant amount of tearing to the seat pan, causing the manikin to collapse through the seat pan. UNMIx exceeded the accepted limit, reaching 0.7510 during impact. After impact the restraint buckle released with 25 lbs of force.

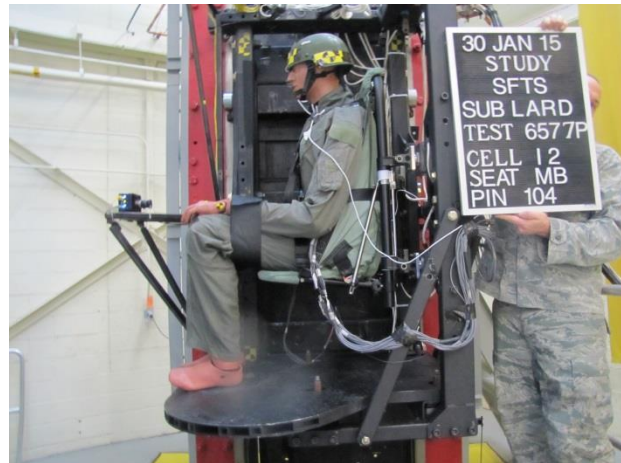
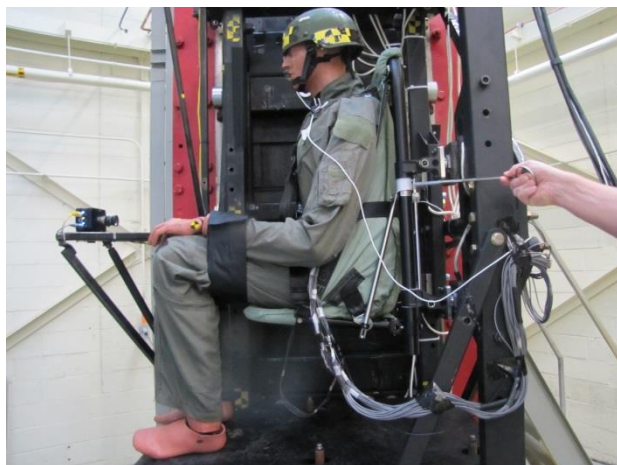
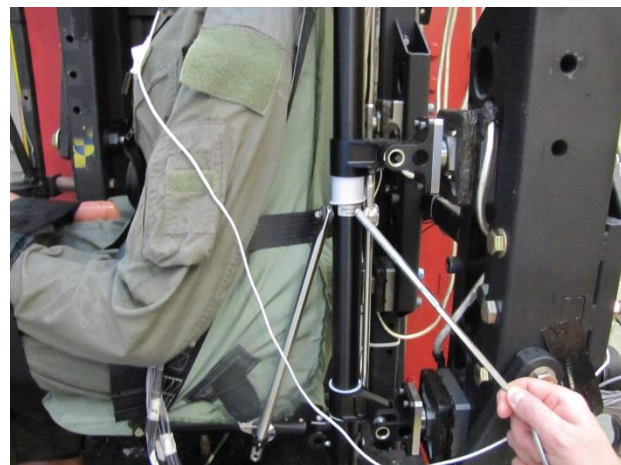
**VDT6577- Cell I2, PV, CH-53, LARD, 14.34 G, 31.39 ft/s, 27.5 ms rise time**

VDT6577 was a repeat of test VDT6575, with the exception of the subject substitution of the LARD manikin. Overall the seat showed no structural damage; however, the stroking mechanism material had been displaced, due to seat stroke upon impact. All electronic data channels were present and continuous allowing data to be successfully collected. After impact the restraint buckle released with 8 lbs of force.

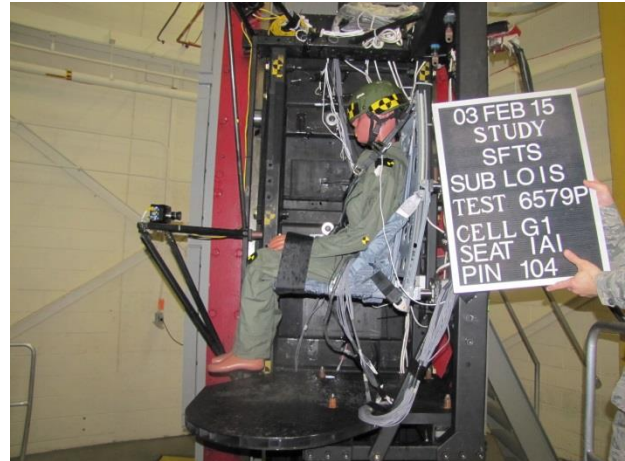
**VDT6579- Cell G1, PV, CV-22, LOIS, 14.71 G, 31.2 ft/s, 28.1 ms rise time**

VDT6579 was the first PV impact test performed with the CV-22. Overall the seat showed no structural damage. The stroking mechanism appeared to be slightly loosened at the bottom connection point during post-test inspection; however, no stroke occurred during impact. Peak lumbar Z exceeded accepted limit, reaching 1102 lbs during impact. After impact the restraint buckle released with 13 lbs of force.

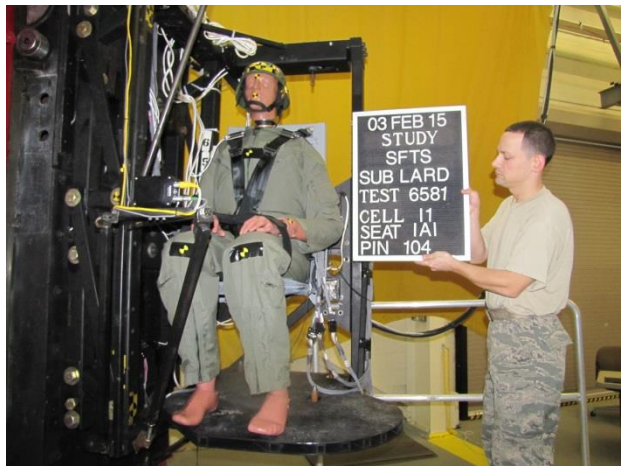
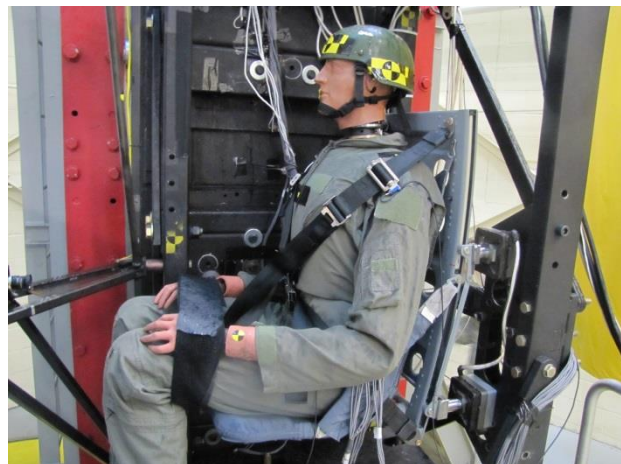
**VDT6581- Cell I1, PV, CV-22, LARD, 15.06 G, 31.53 ft/s, 27.5 ms rise time**

VDT6581 was a repeat of test VDT6579, with the exception of the subject substitution of the LARD manikin. Post-test examination indicated small stroke had occurred and the stroking mechanism appeared to be slightly loosened at the bottom connection point. Besides slight scarring to the inner stroking mechanism material and loosening of stoking rod, no structural damage was recorded. After impact the restraint buckle released with 8 lbs of force.

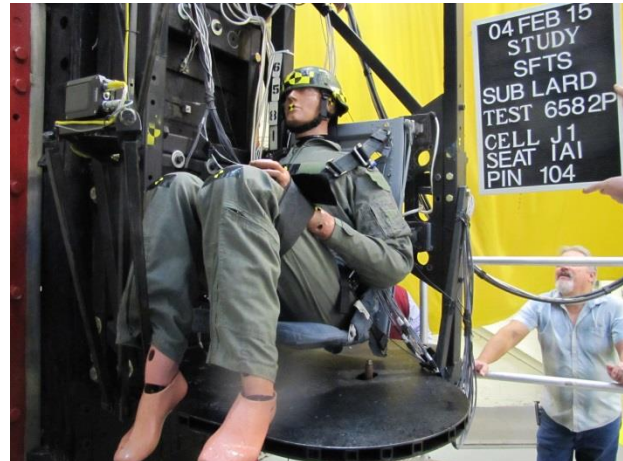
**VDT6582- Cell J1, PV, CV-22, LARD, 32.10 G, 48.88 ft/s, 18.7 ms rise time**

VDT6582 repeated the conditions of the previous test at a higher energy level. Damage to the seat fixture from the high level impact was fairly extensive. Outer stroking mechanism rods on both sides detached after maximum stroke was achieved. Seat stroke also resulted in the inner stroking material to become scarred upon impact, as well as subsequent denting to the back of the seat fixture. After impact the restraint buckle released with 7.5 lbs of force.

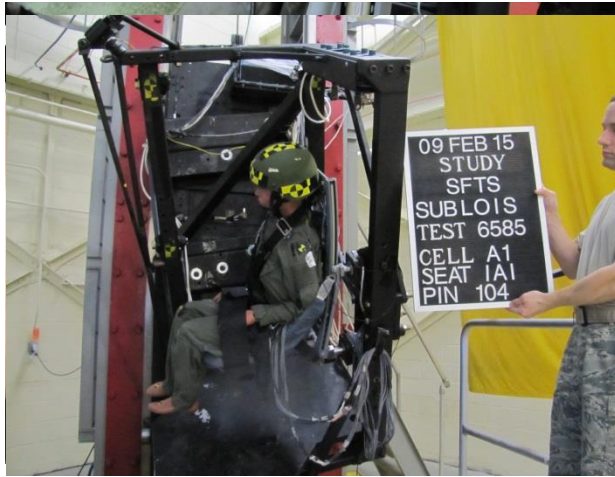
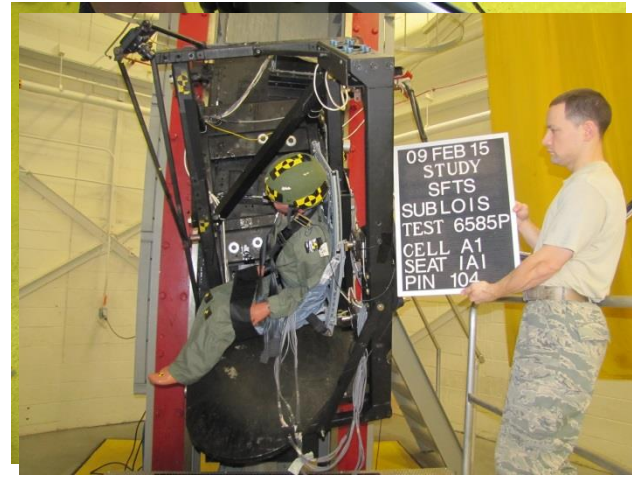
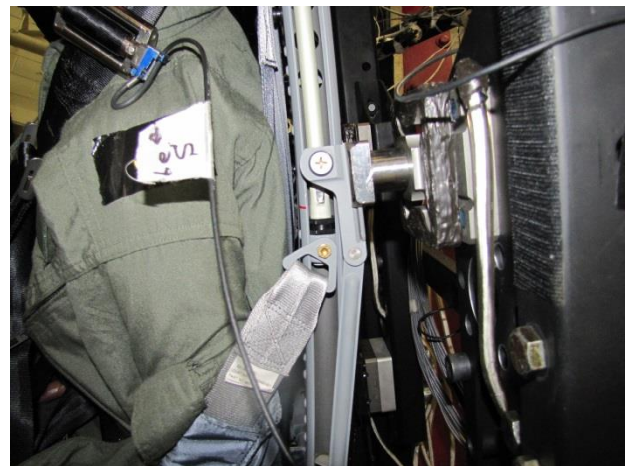
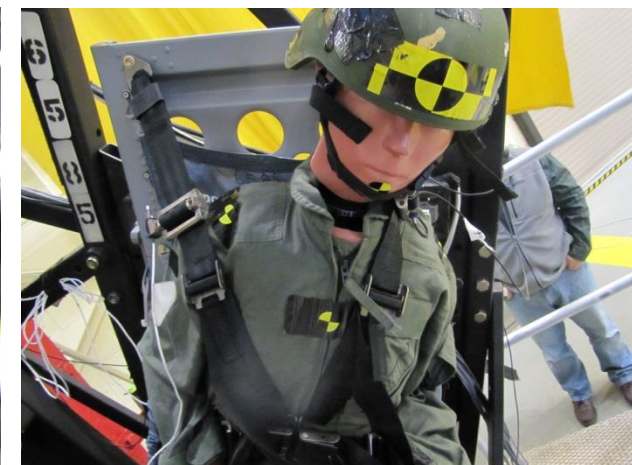
**VDT6585- Cell A1, CV, CV-22, LOIS, 24.59 G, 40.56 ft/s, 35.4 ms rise time**

VDT6585 was the first CV impact test performed in this program. Post-test examination indicated slight seat stroke had taken place, possibly loosening the outer stroking mechanism at the bottom connection point. Both peak lumbar Z and neck moment index X (UNMIx) exceeded accepted limits, reaching 1391 lbs and 0.5367, respectively. After impact the restraint buckle released with 21 lbs of force.

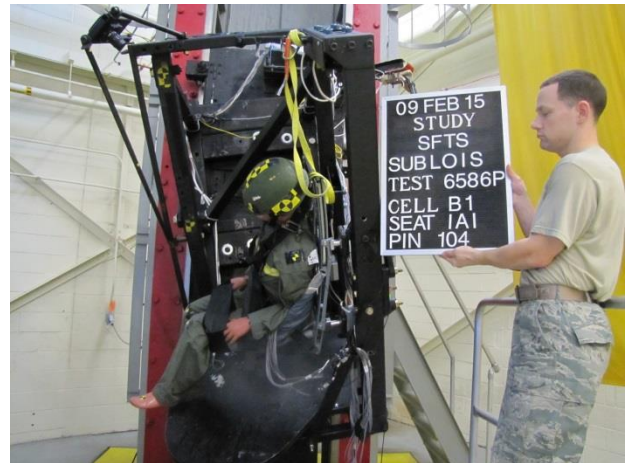
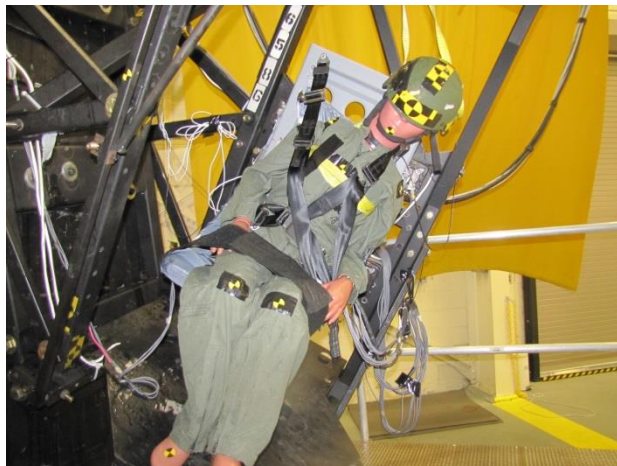
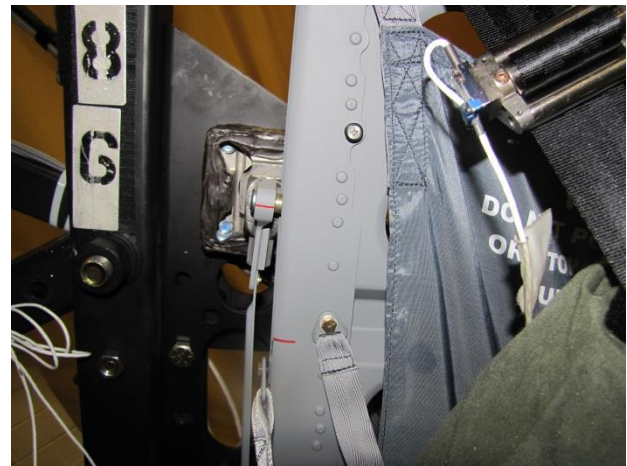
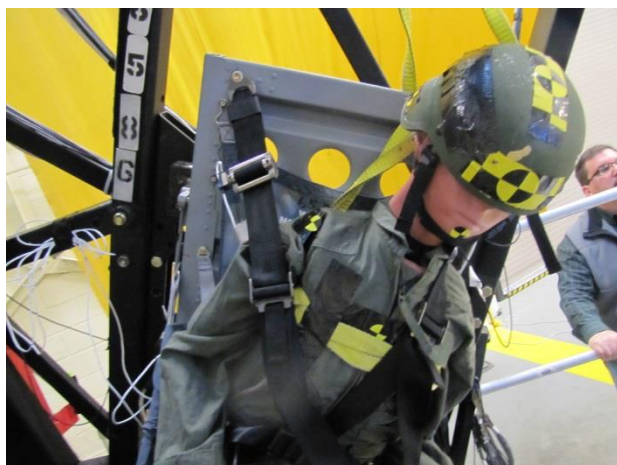
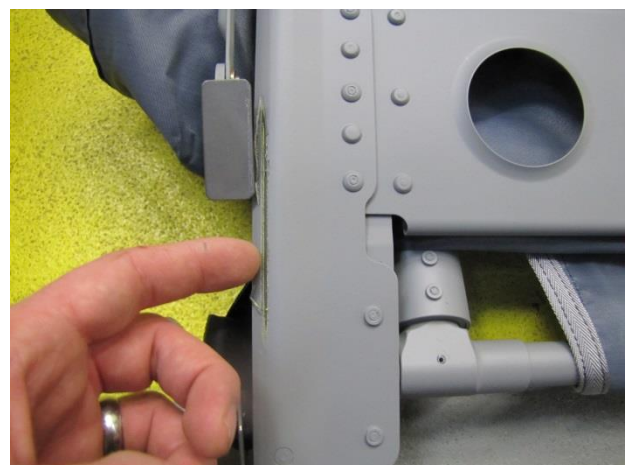
**VDT6586- Cell B1, CV, CV-22, LOIS, 29.88 G, 48.82 ft/s, 18.9 ms rise time**

VDT6586 reiterated test conditions in the previous test, VDT6585, but at a higher energy level. Seat stroked upon impact, causing scarring to the inner stroking mechanism material on both sides. Additional scarring was discovered during post-test inspection, located on the bottom left corner of the seat back due to the bulky piece at the bottom of the outer stroking mechanism. Peak lumbar Z exceeded accepted limit, reaching 1604 lbs during impact. After impact the restraint buckle released with 18 lbs of force.

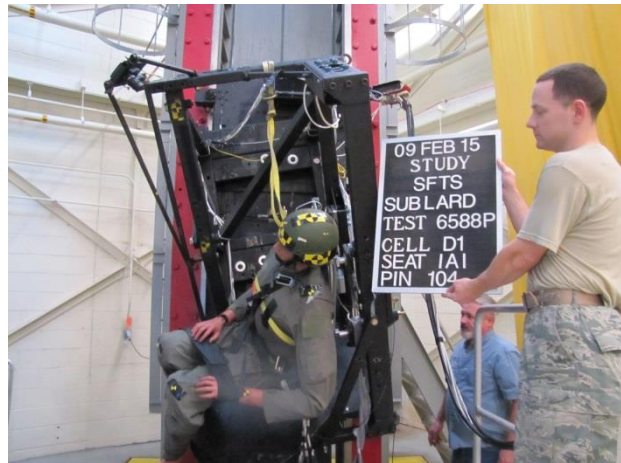
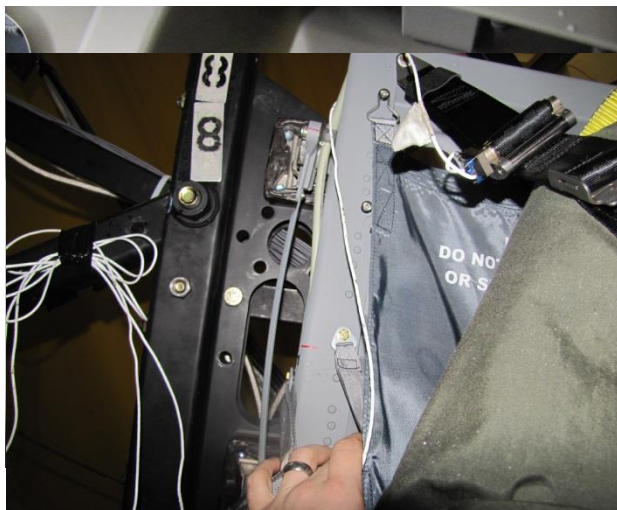
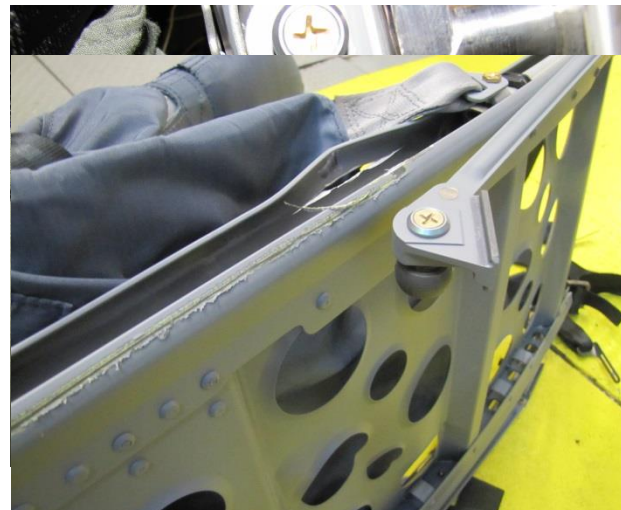
VDT6588- Cell D1, CV, CV-22, LARD, 29.71 G, 48.93 ft/s, 18.4 ms rise time

VDT6588 repeated the conditions of the previous test at a higher energy level. Damage to the seat fixture from the high level impact was fairly extensive. Seat stroke resulted in the inner stroking rod material and the surface on the side of the seat fixture to become scarred upon impact. The right outer stroking mechanism detached at the bottom connection point, while the inner stroking rod on the right was forced to bow out during stroke sequence. Subsequent denting and cracking to the back of the seat fixture was also discovered, as well as tethering to the left shoulder restraint. Torso belt force, neck moment index X (UNMIx), and neck moment index Z (UNMIz) exceeded accepted limits, reaching 2441 lbs, 1.7222, 0.5223, respectively. After impact the restraint buckle released with 38 lbs of force.

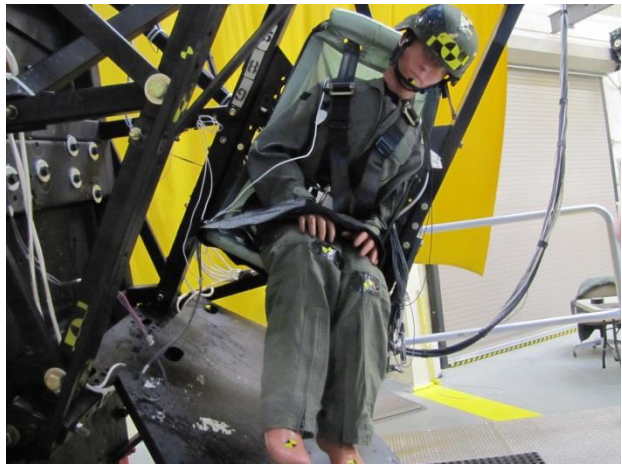
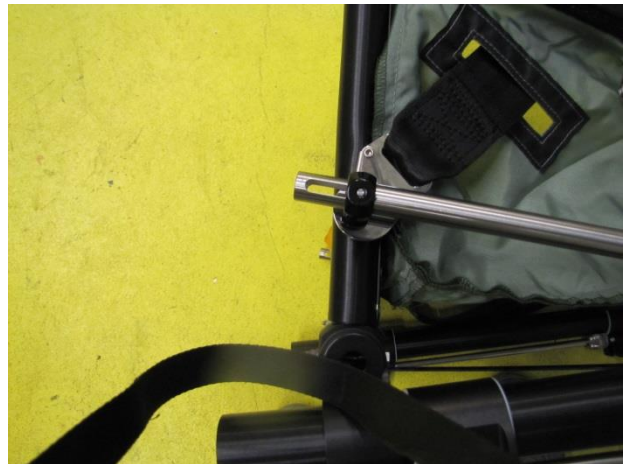
**VDT6589- Cell A2, CV, CH-53, LOIS, 24.25 G, 40.51 ft/s, 32 ms rise time**

VDT6589 was the first CV impact test performed with the CH-53 seat. Overall the seat showed no structural damage; however, the stroking mechanism material may have slightly been displaced, indicating seat stroke had occurred. All electronic data channels were present and continuous allowing data to be successfully collected. Peak lumbar Z exceeded accepted limit, reaching 2167 lbs during impact. After impact the restraint buckle released with 8 lbs of force.

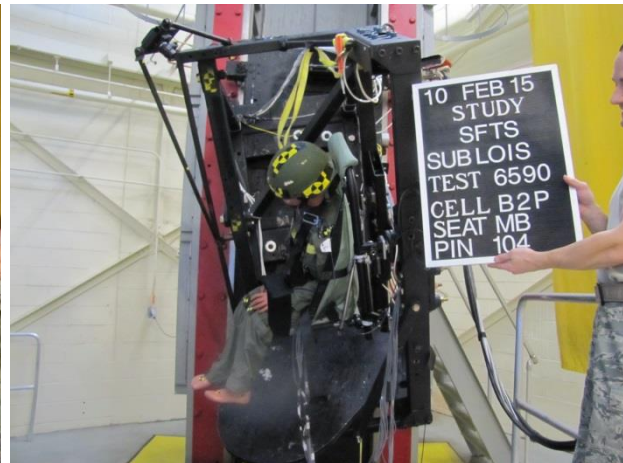
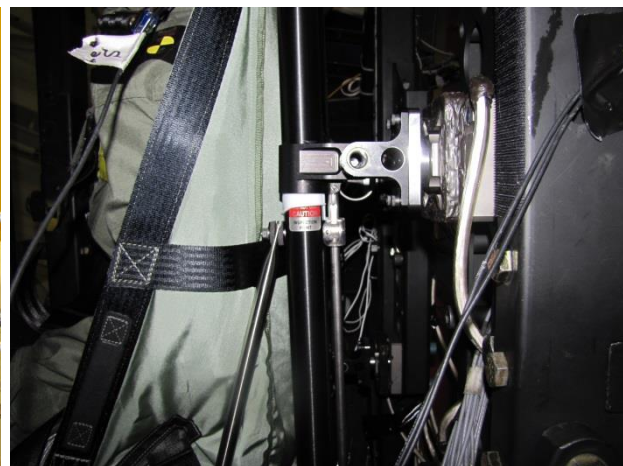
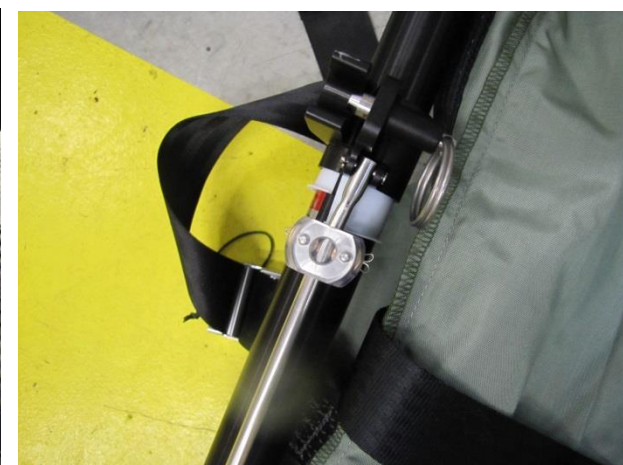
**VDT6590- Cell B2, CV, CH-53, LOIS, 29.96 G, 48.92 ft/s, 19.5 ms rise time**

VDT6590 reiterated test conditions in the previous test, VDT6589, but at a higher energy level. Although this impact was of greater magnitude than the previous test, the seat still showed no structural damage post-impact. It was discovered the stroking mechanism material was more displaced after the stroke sequence than in the previous test. Both the chest resultant and peak lumbar Z exceeded accepted limits, reaching 64.34 G and 2522 lbs, respectively. After impact the restraint buckle released with 6 lbs of force.

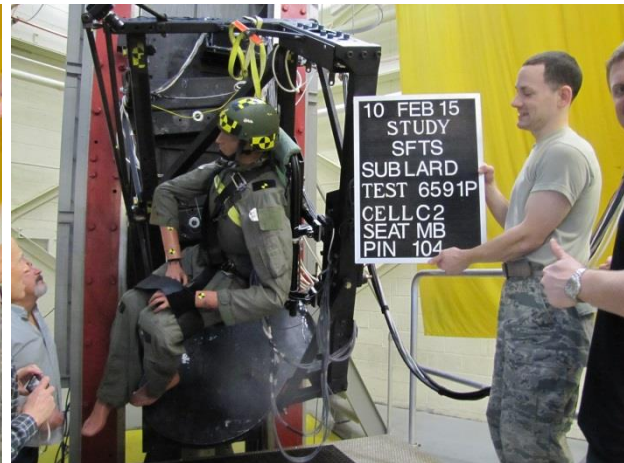
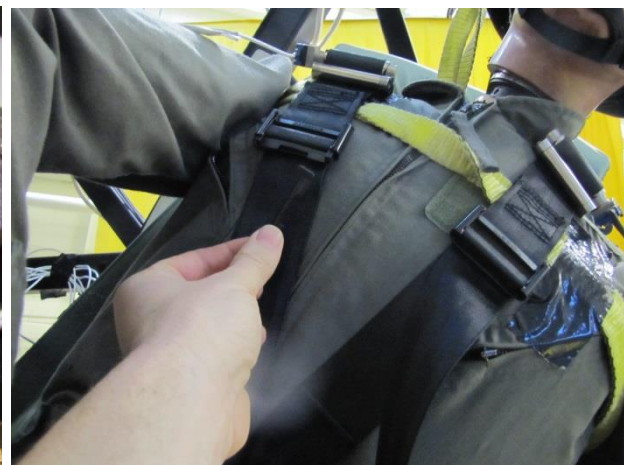
**VDT6591- Cell C2, CV, CH-53, LARD, 24.19 G, 40.51 ft/s, 20.9 ms rise time**

VDT6591 was a repeat of test VDT6589, with the exception of the subject substitution of the LARD manikin. Overall the seat showed no structural damage; however, the stroking mechanism material may have slightly been displaced, indicating seat stroke had occurred. Both torso belt force and neck moment index X (UNMIx) exceeded accepted limits, reaching 2877 lbs and 0.6638, respectively. After impact the restraint buckle released with 12 lbs of force.

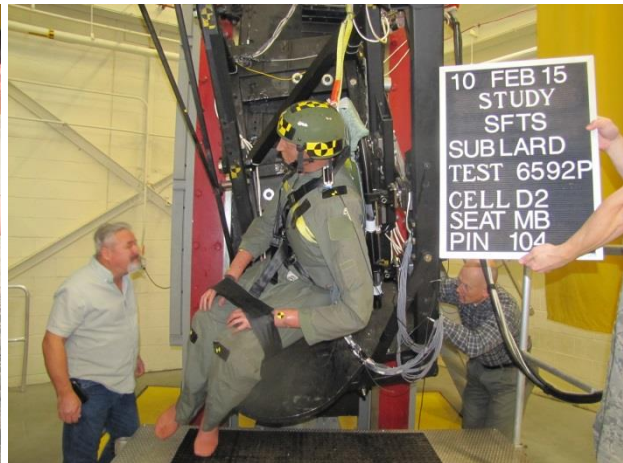
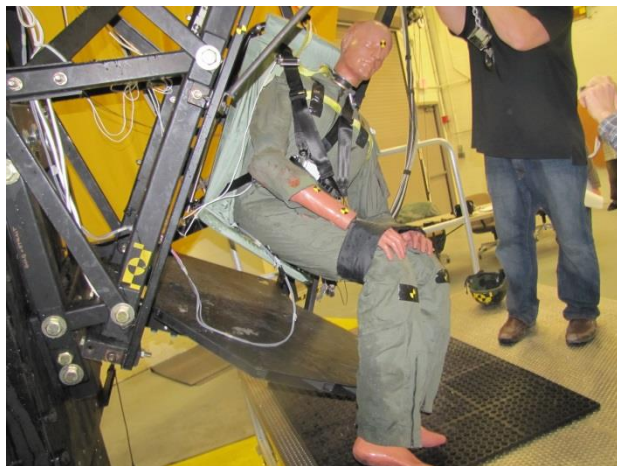
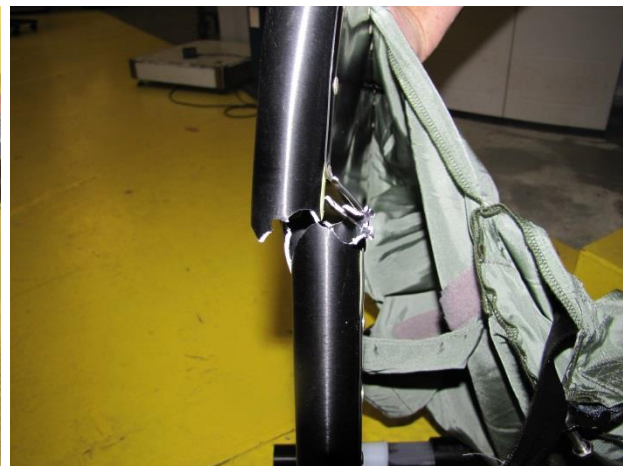
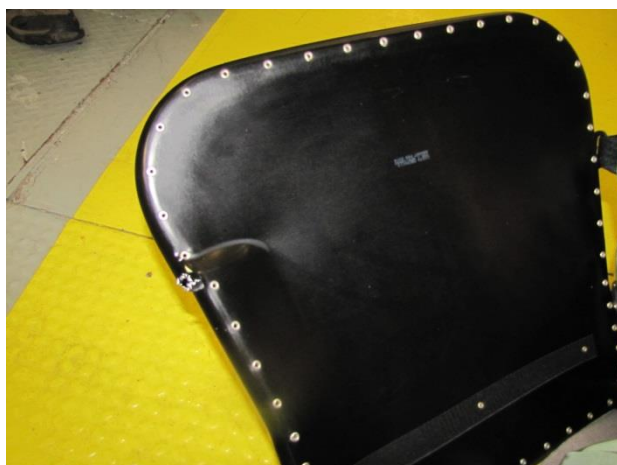
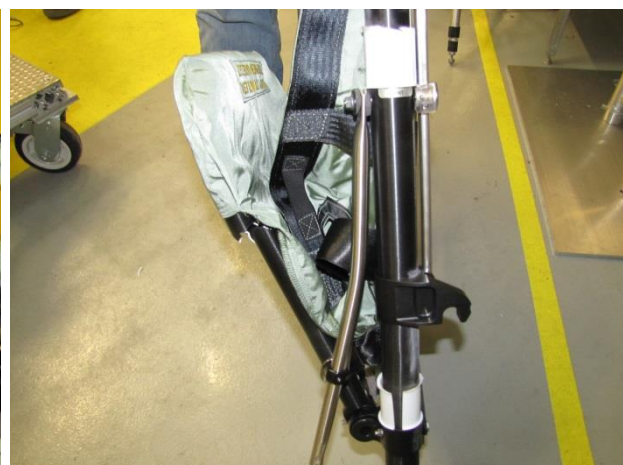
**VDT6592- Cell D2, CV, CH-53, LARD, 30.11 G, 48.9 ft/s, 19.3 ms rise time**

VDT6592 repeated the conditions of the previous test at a higher energy level. Seat stroke resulted in total displacement and minor chipping of the stroking mechanism material on both sides. Post-test inspection revealed movement or slight displacement of the piece connecting the seatback to the mounting portion of the seat; this piece also covers the stroking material, allowing sliding and stroke to occur. Subsequent denting and fracture discovered on the side of the seat pan, along with bending of the slanted seat pan support rod. Both torso belt force and neck moment index X (UNMIx) exceeded accepted limits, reaching 3375 lbs and 0.9153, respectively. After impact the restraint buckle released with 38 lbs of force.

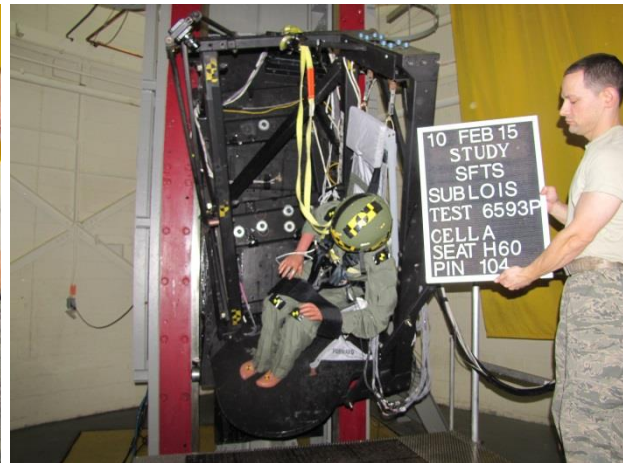
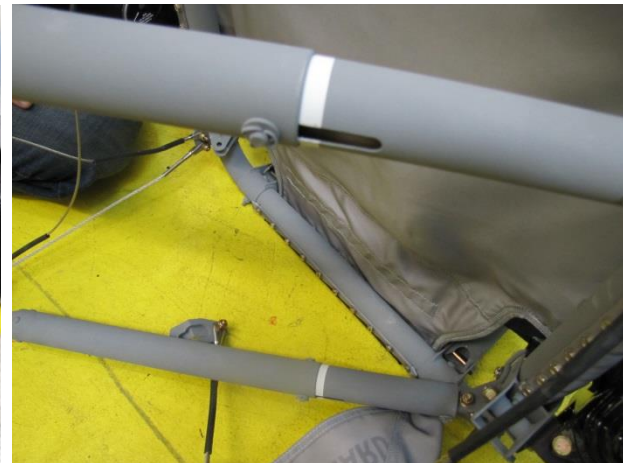
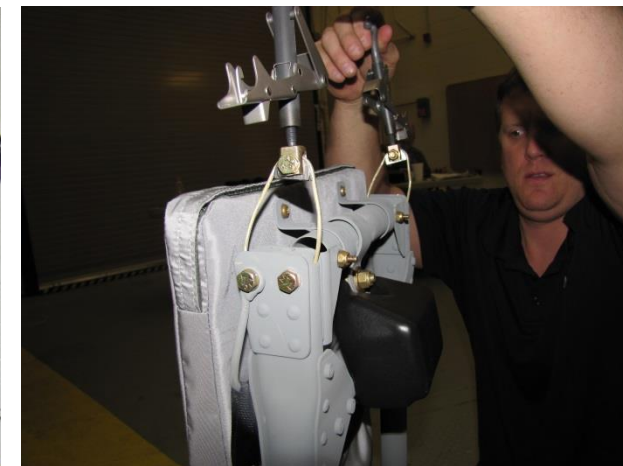
**VDT6593- Cell A, CV, Legacy H-60, LOIS, 24.33 G, 40.45 ft/s, 22.7 ms rise time**

VDT6593 was the first test performed with the Legacy H-60 seat in the CV impact orientation. The seat did stroke at both top mount points and slightly at both seat legs. Overall the seat showed no structural damage; however, the middle restraint strap became tethered upon impact at the strap junction. Both peak lumbar Z and neck moment index X (UNMIx) exceeded accepted limits, reaching 1090 lbs and 0.5573, respectively. After impact the restraint buckle released with 20 lbs of force.

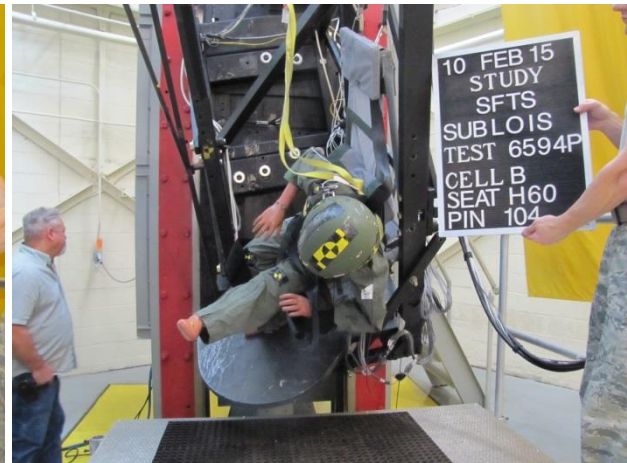
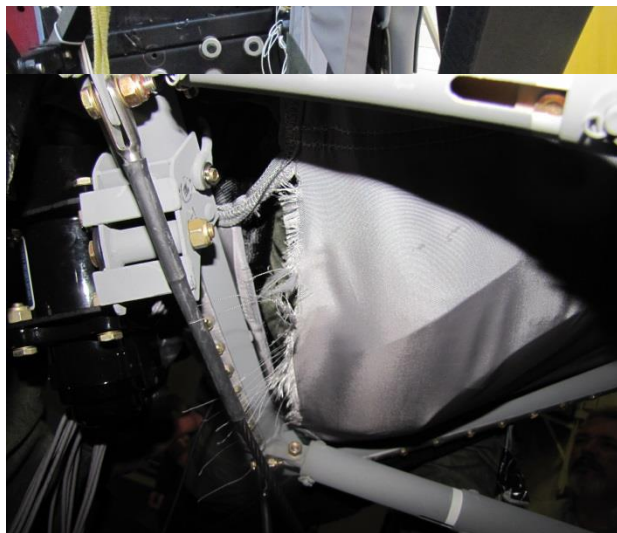
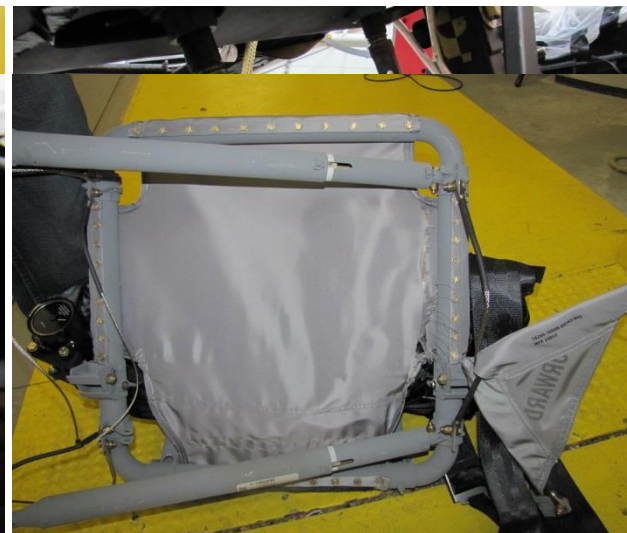
**VDT6594- Cell B, CV, Legacy H-60, LOIS, 30.55 G, 48.57 ft/s, 19.1 ms rise time**

VDT6594 reiterated test conditions in the previous test, VDT6593, but at a higher energy level. Shoulder restraints were unable to stay taut and hold the manikin in place during impact, leaving the manikin partially hunched over out of the seat. Main damage recorded during inspection was to the seat pan, where it was torn rather extensively on the left side. Both peak lumbar Z and neck moment index X (UNMIx) exceeded accepted limits, reaching 1130 lbs and 0.9575, respectively. After impact the restraint buckle released with 31 lbs of force.
